# ETHICO N,INC.

September 30, 1987

IR MICROSCOPY OF EXPLANTED PROLENE\*
RECEIVED FROM PROF. R. GUIDOIN

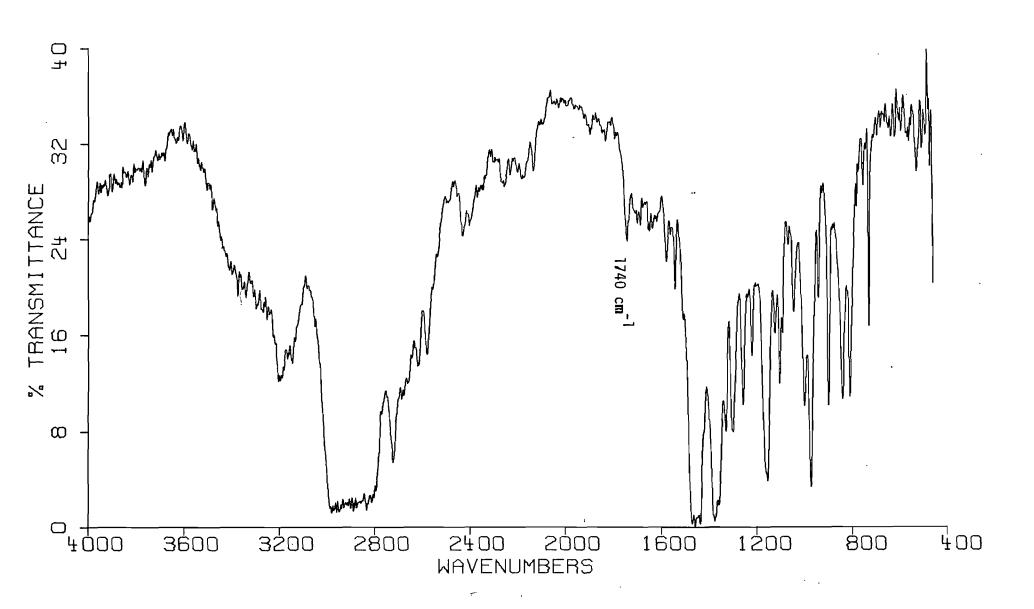
Figure 1

PROLENE EXPLANT (2 YR) 83D062 + 83TM020

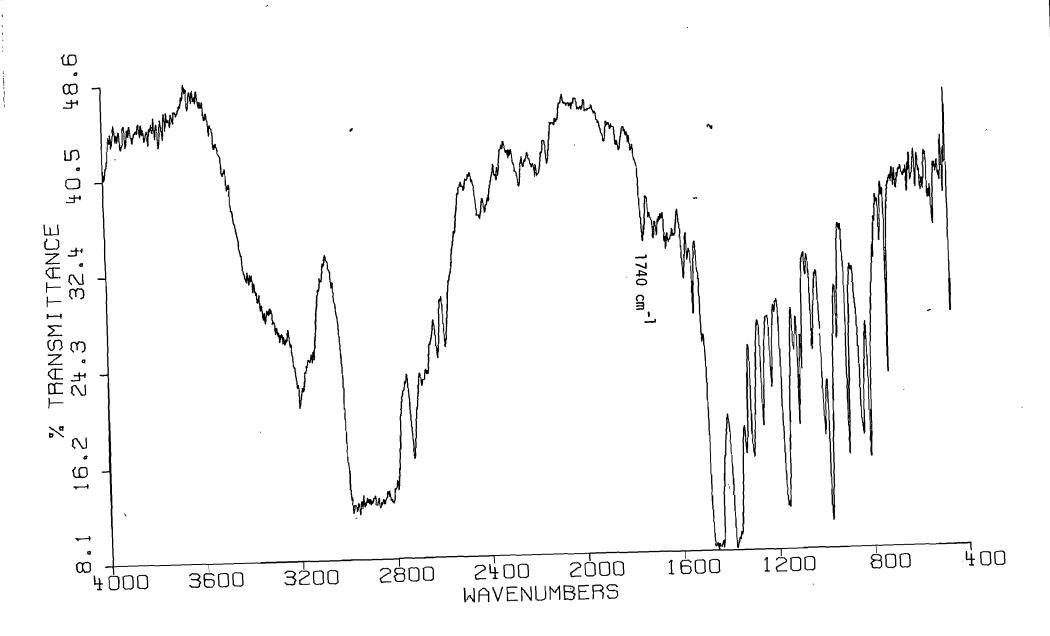
Figure 2

PROLENE EXPLANT (2 YR) 83D062 + 83TM020 SIZE 2/0? 7/27/87 D.F.BURKLEY

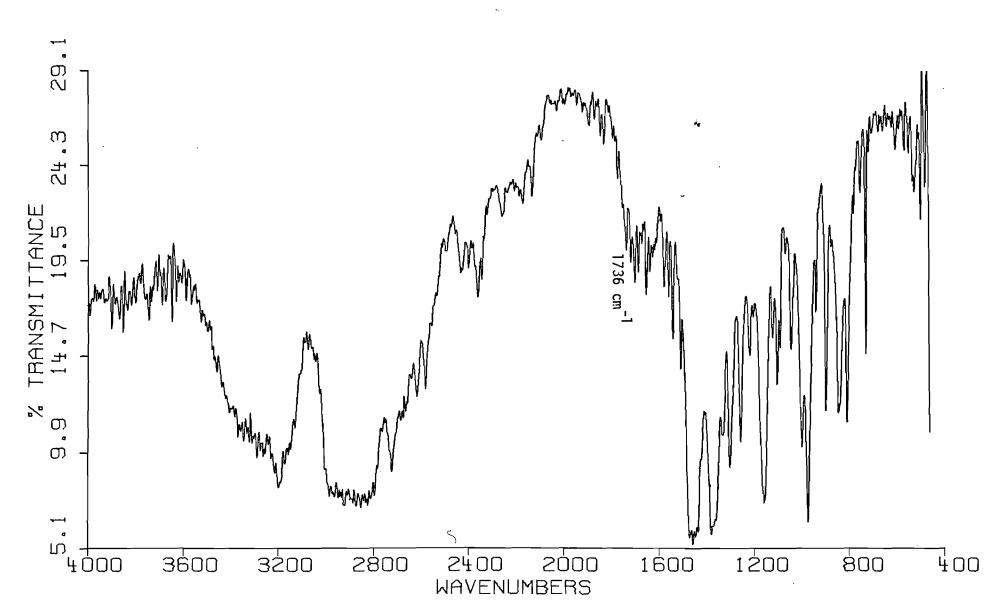
Figure 3

PROLENE EXPLANT (8 YR) 83D035 2/0

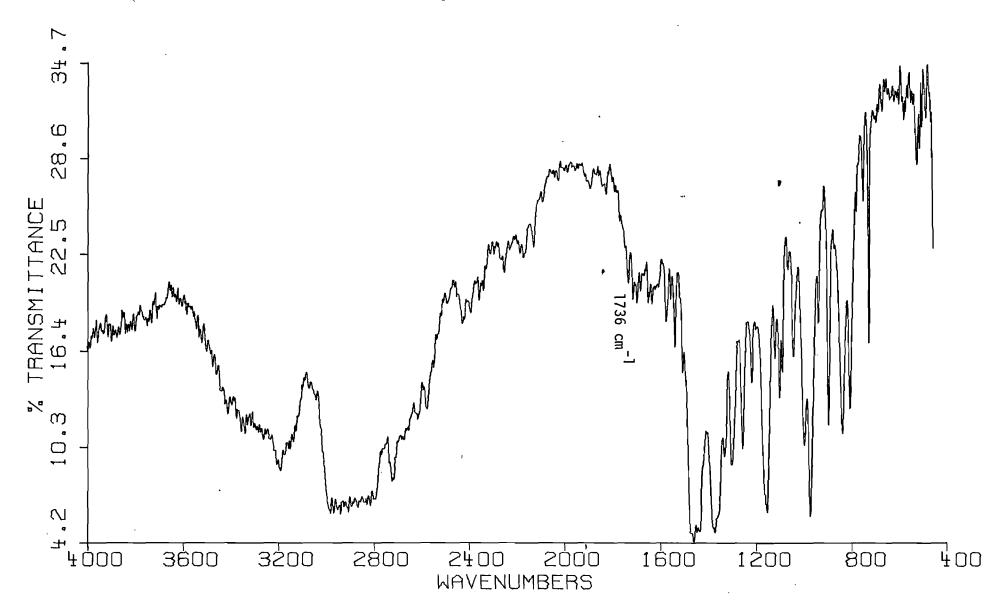
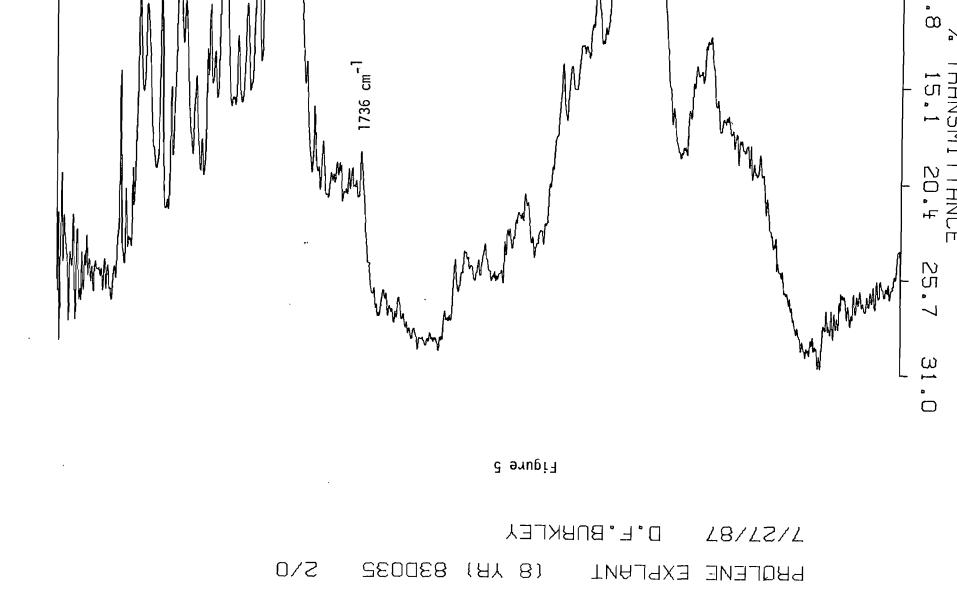
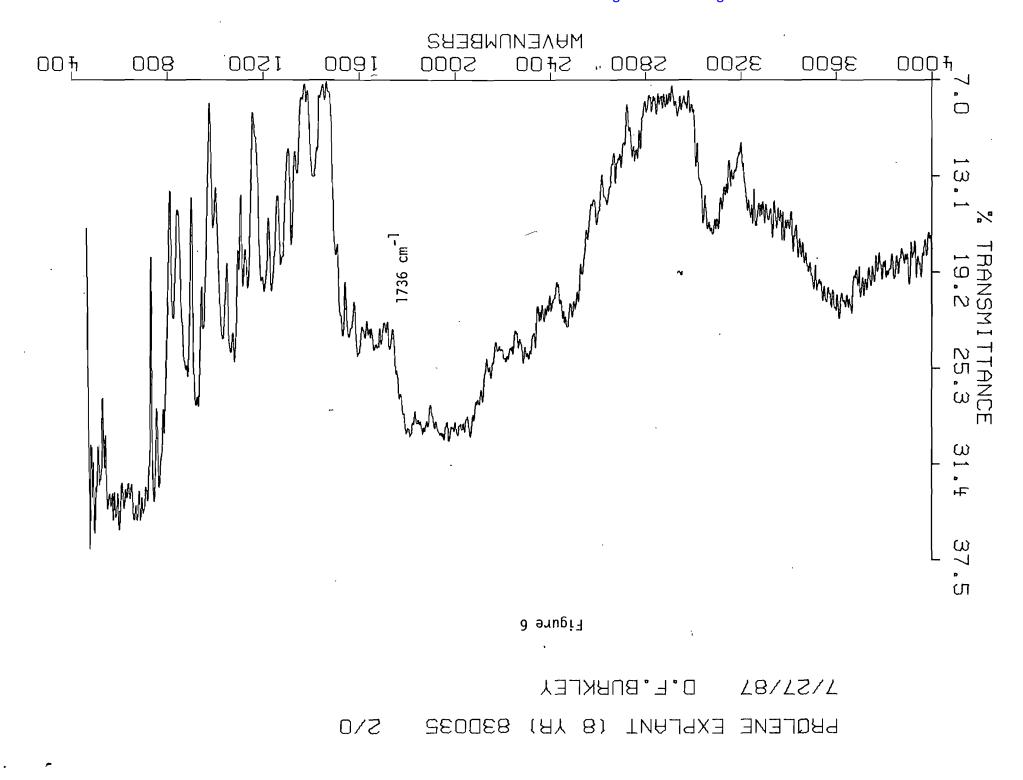
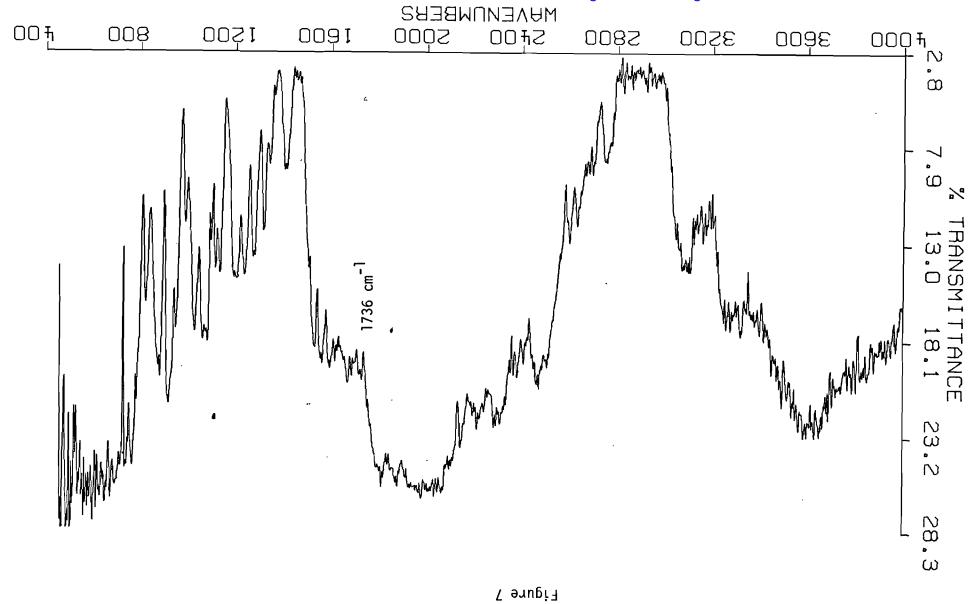
Figure 4

PROLENE EXPLANT (8 YR) 83D035 2/0 7/27/87 D.F.BURKLEY

PRÖLENE EXPLANT (8 YR) 830035 2/0

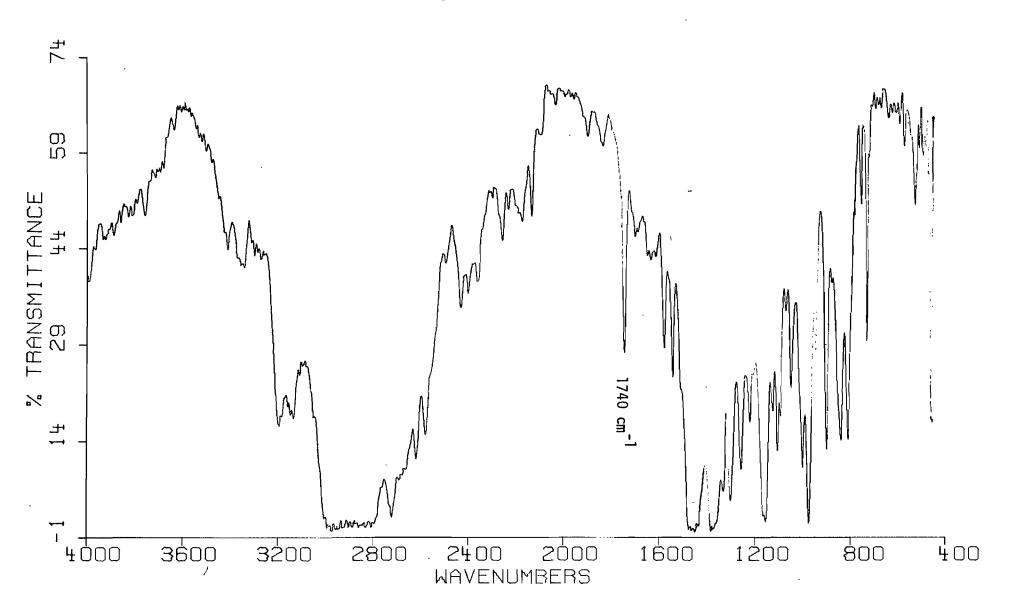
Figure 8

SIZE O PROLENE STERILE PACKAGE IR MICROSCOPY 9/1/87 D.F.BURKLEY

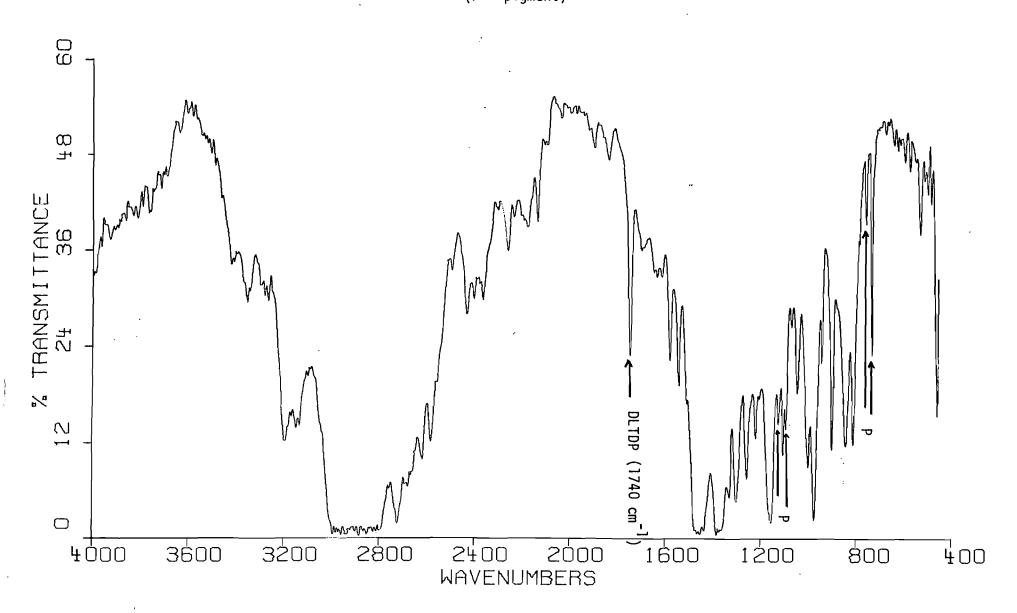
Spectra of samples examined "as is" show remarkable similarity between explanted suture and unimplanted suture. All major polypropylene and pigment bands are observed (Figure 9). The 1740 cm<sup>-1</sup> band, seen strongest in the sterile product, is due to dilauryl thiodipropionate (DLTDP) additive. The DLTDP appears reduced in the 2-year sample spectra and further reduced in the 8-year sample spectra. DLTDP is not observed in the surface scraping spectra.

Figure 9 - DLTDP and pigment bands shown (P = pigment)

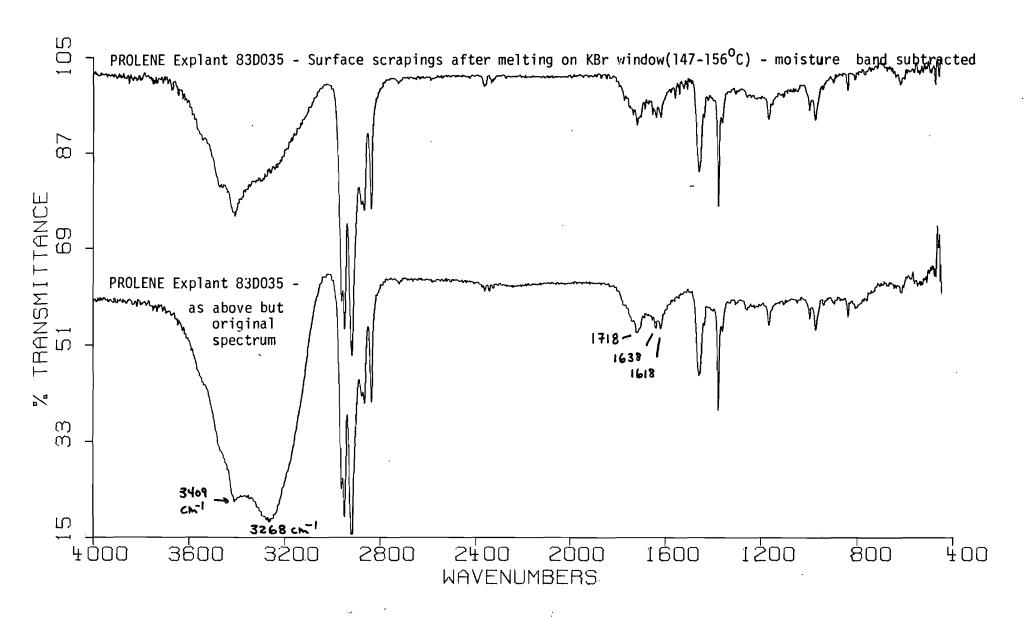
Figure 10

The surface scrapings of 83D035 were melted at 147°-156°C on the Mettler hot stage. This is the melting range previously observed for oxidatively degraded polypropylene. IR microscopy of the melted film produced (Figures 10 & 11) yielded good spectra.

The surface scrapings spectra of 83D035 clearly indicate polypropylene, but also three or four other broadened bands. Table I explains the possible functionalities determined from a library search of the IR bands not normally seen in polypropylene.
